El Don Sewer Replacement

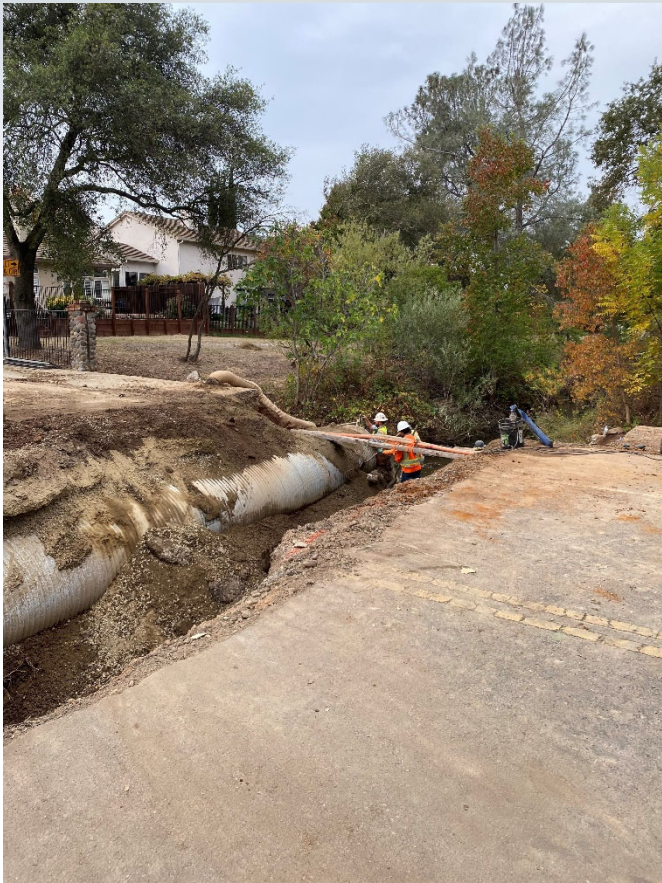
Existing deteriorated and failing corrugated metal pipe (CMP) on El Don Drive.
